ENGINEERING REPORT (Initial Draft)

October 4, 2011

INSURED: William Magee

LOSS LOCATION: 6968 North Hamburg Road, Oldenburg, Indiana 47036

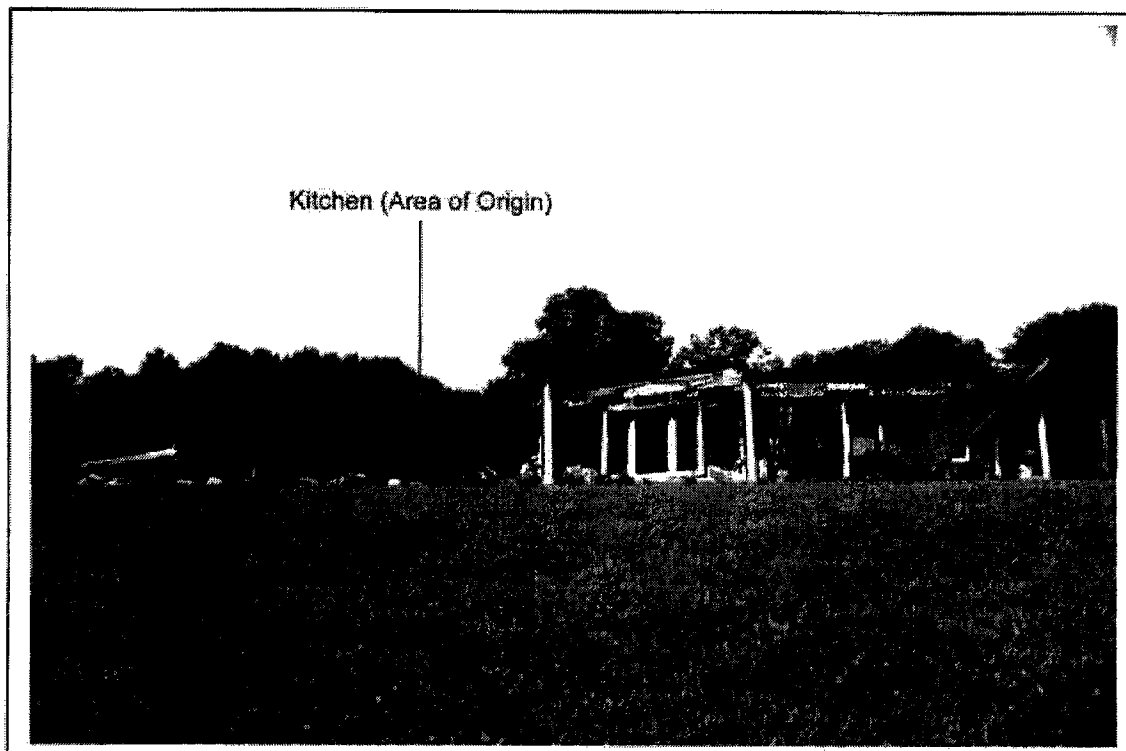
001

Examination of the structure revealed heavy fire damage and collapse with the extreme localized damage in the area of the kitchen refrigerator (**Photos 001, 002, 003, 004, 005, 006, & 007**). This extremely concentrated damage occurred with this refrigerator closely surrounded by drywall on three sides. Mr. Magee provided documentation that identified the refrigerator as a 25 cubic foot Sears Kenmore Elite Brand Trio model 79577549600 purchased and installed in October of 2006 from Sears as a replacement for the original refrigerator that had failed.

View of the east
(front) of the
structure

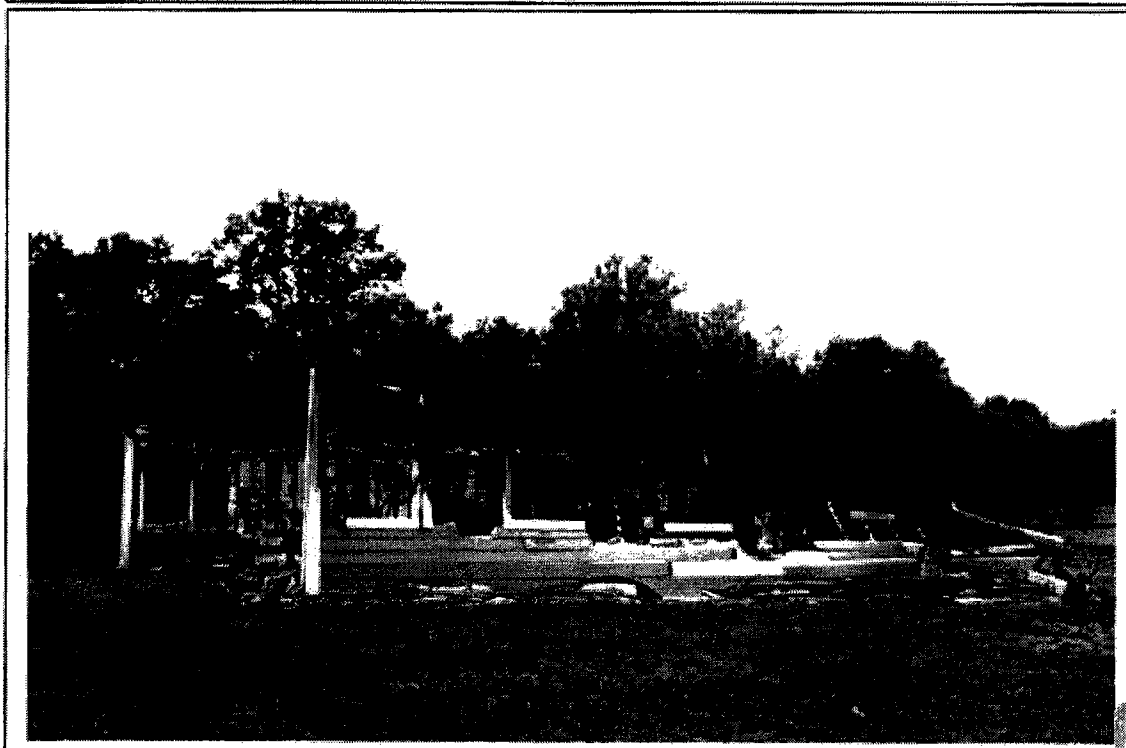
002

View of the
south side of the
structure

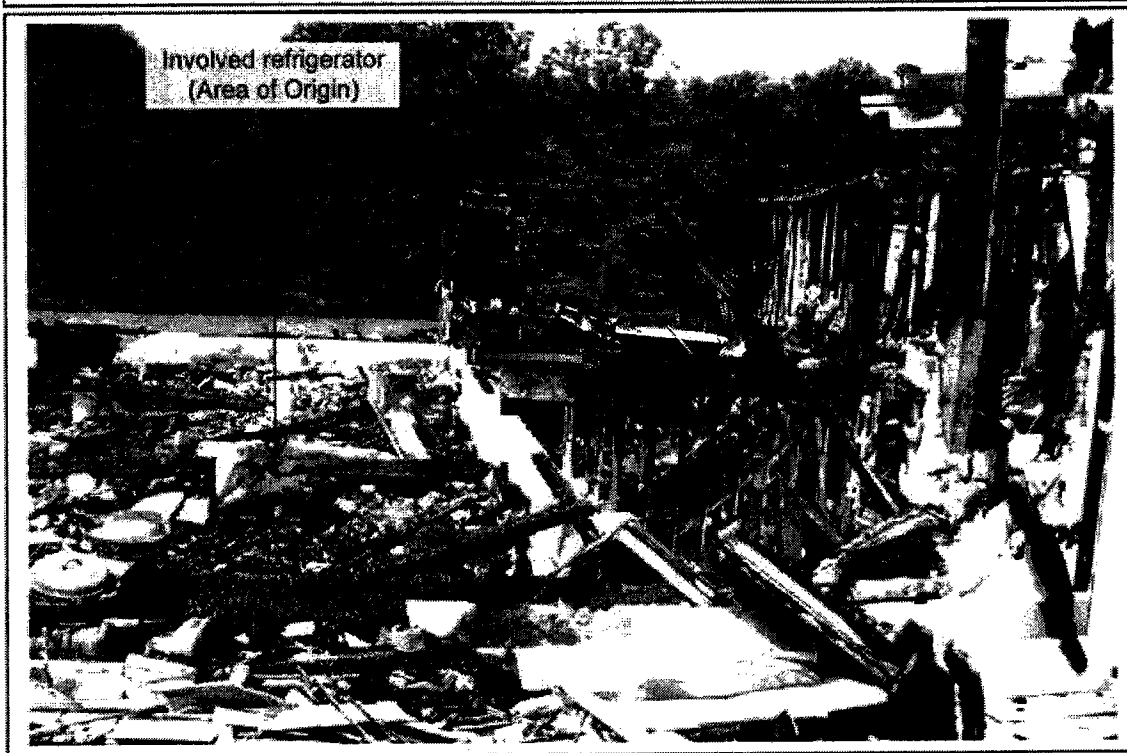
004

View looking
west from the
front porch

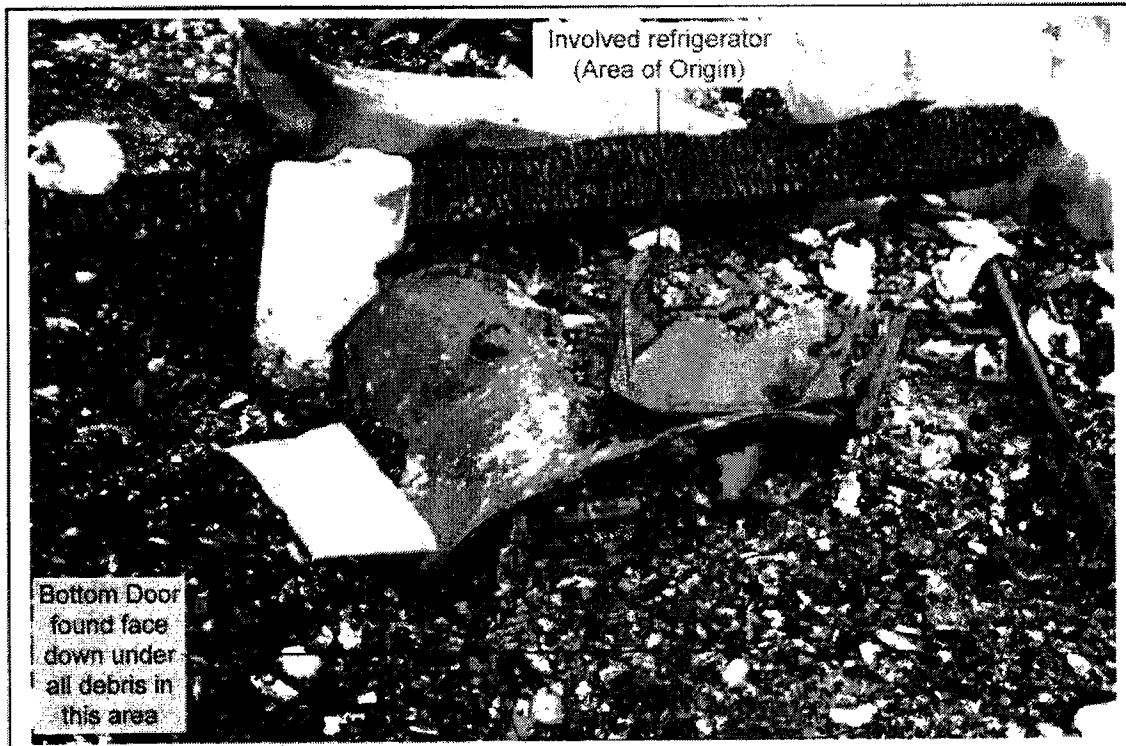
005

**View of the
involved
refrigerator**

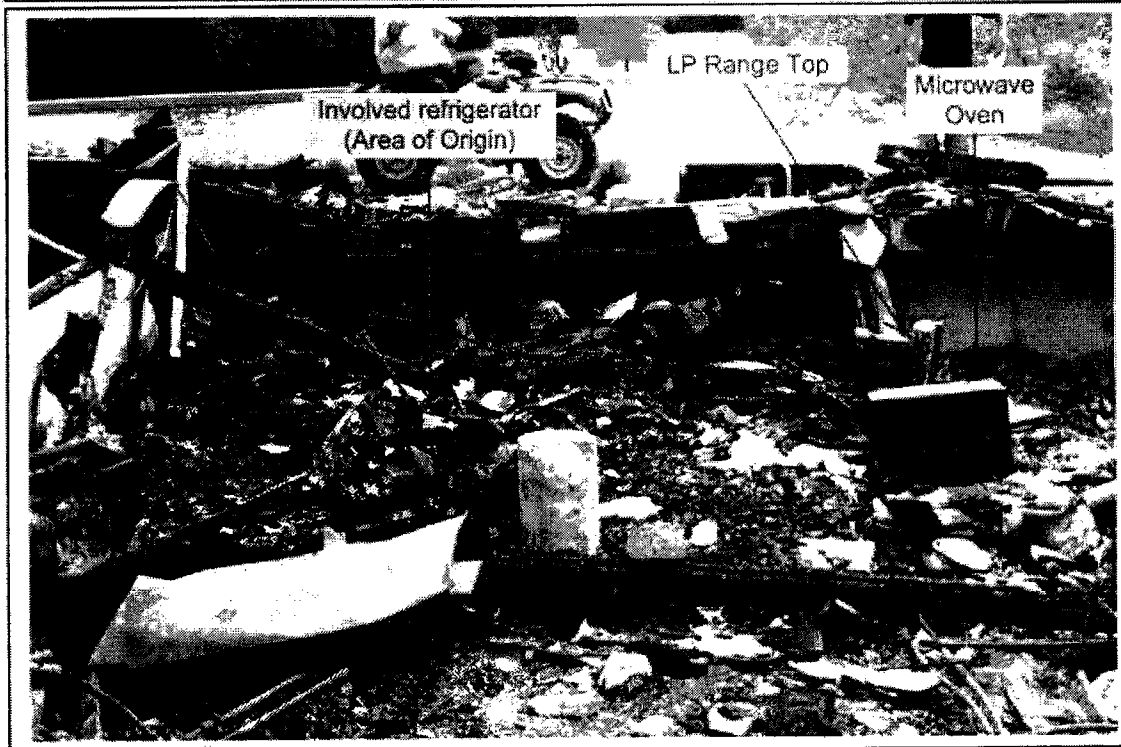
006

Damage to all other appliances was consistent with varying degrees of fire attack (**Photos 006, 009, 010, 012, 013, 015, 016, 017, 018, 019, & 020**). There was no evidence of branch wiring or other competent ignition sources located under the floor under the refrigerator.

**View of the
kitchen facing
east towards the
front porch**

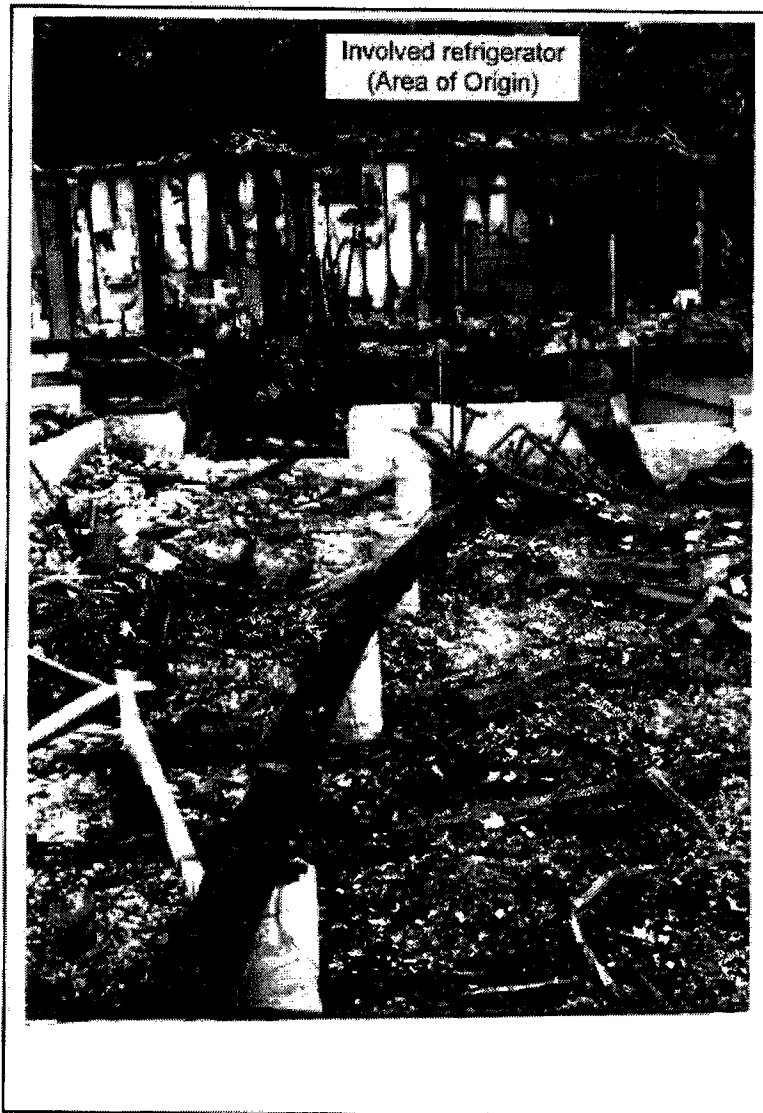
007

View facing north

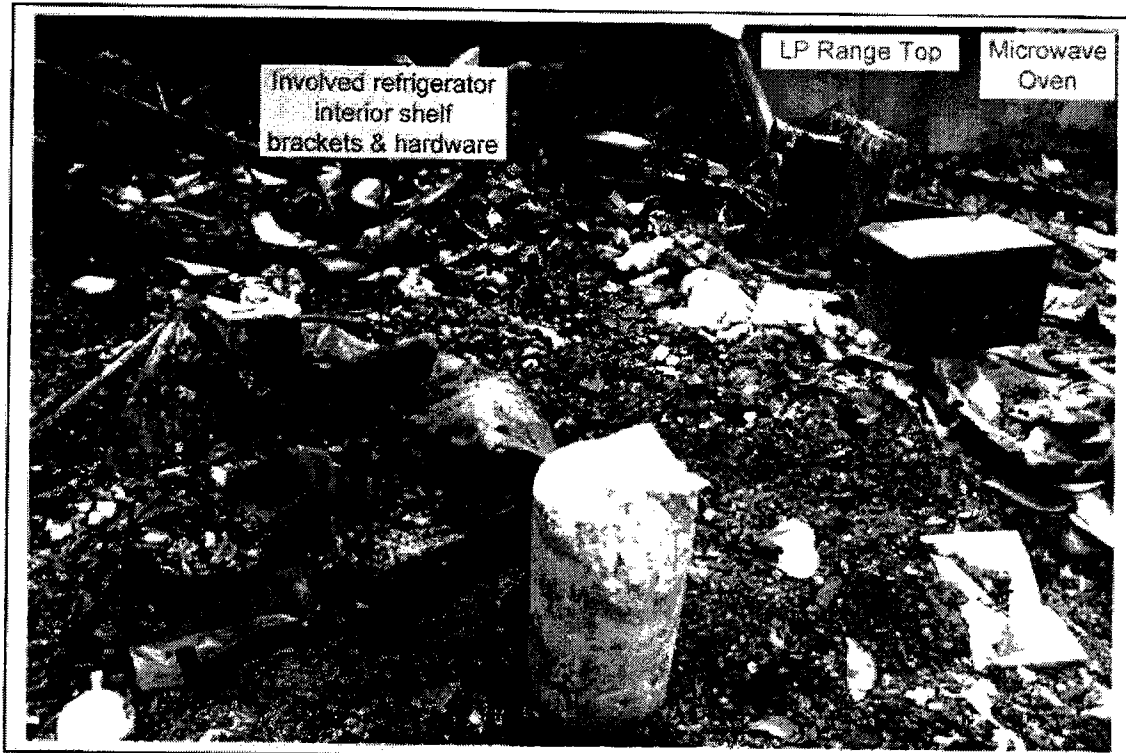
009

This refrigerator had a bottom freezer door with two side-by-side doors above and was surrounded on three sides by fully enclosed drywall walls. This refrigerator had extreme fire damage to the point that the steel enclosure and other remains had collapsed to a height of about 16 inches and less (**Photos 008, 009, 010, 011, 014, 021, 022, 023, 045, 046, & 047**). The bottom freezer door front was found lying face down on a protected area of kitchen floor (**Photos 023, 024, 025, 026, 027, 028, 029, 030, 031, 032, 033, 034, 035, 036, 037, & 038**). The above side-by-side doors were in the area above this door. Inspection of the area around and under the refrigerator revealed that a section of the subfloor under the refrigerator was totally consumed with the refrigerator metal base sitting on the exposed gravel crawl space surface (**Photos 039 & 040**). Electrical conductor and component fragments consistent with those used in this type of refrigerator were found in and around this refrigerator. A few of these fragments exhibited damage consistent with electrical activity.

The extremely concentrated fire damage to this refrigerator relative to the other appliances, the degree of inward collapse, and the position of the doors was consistent with greater fire damage and fire emanating from inside this refrigerator and not external fire attack (Photos 008, 009, 010, 011, 014, 021, 022, 023, 045, 046, & 047).

**View of the
kitchen**

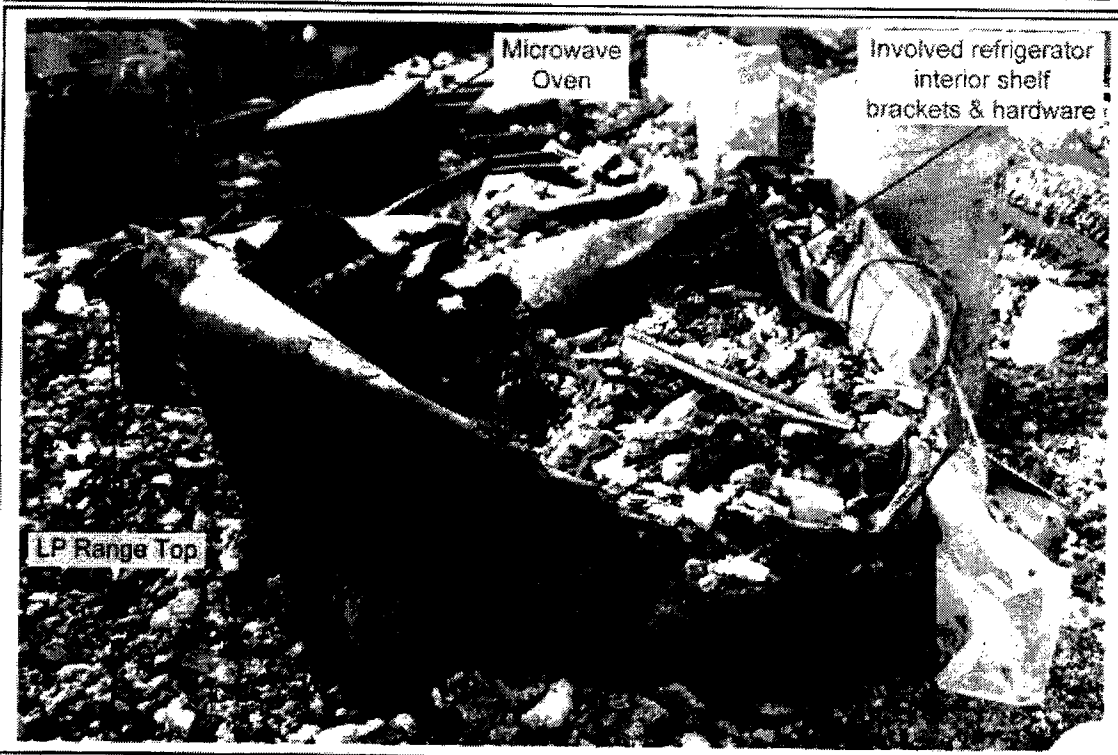
010

**View of the
involved
refrigerator**

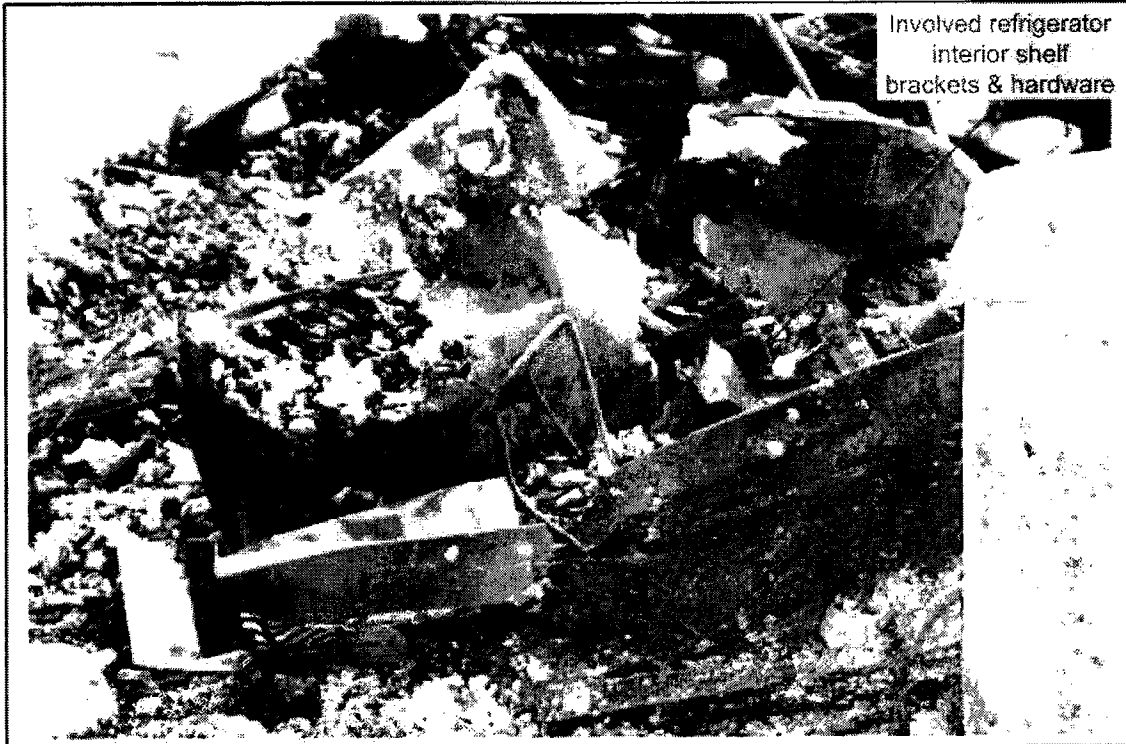
011

Close up view
of the involved
refrigerator

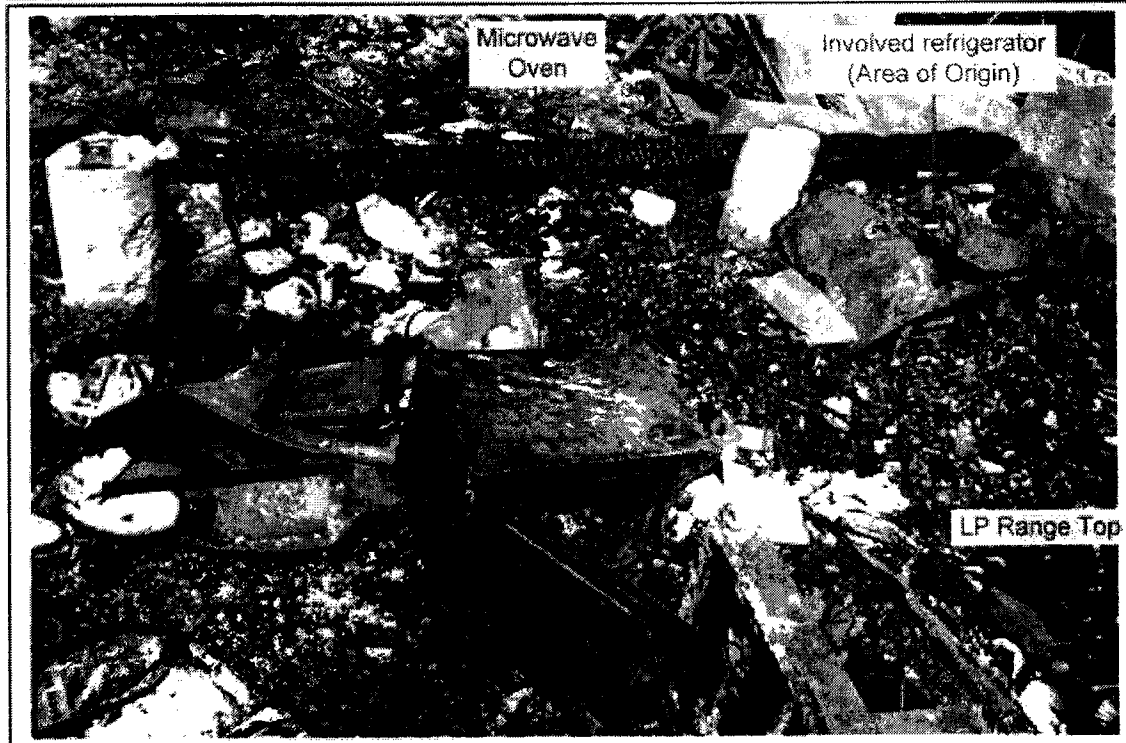
012

View of the
microwave oven
near the
involved
refrigerator

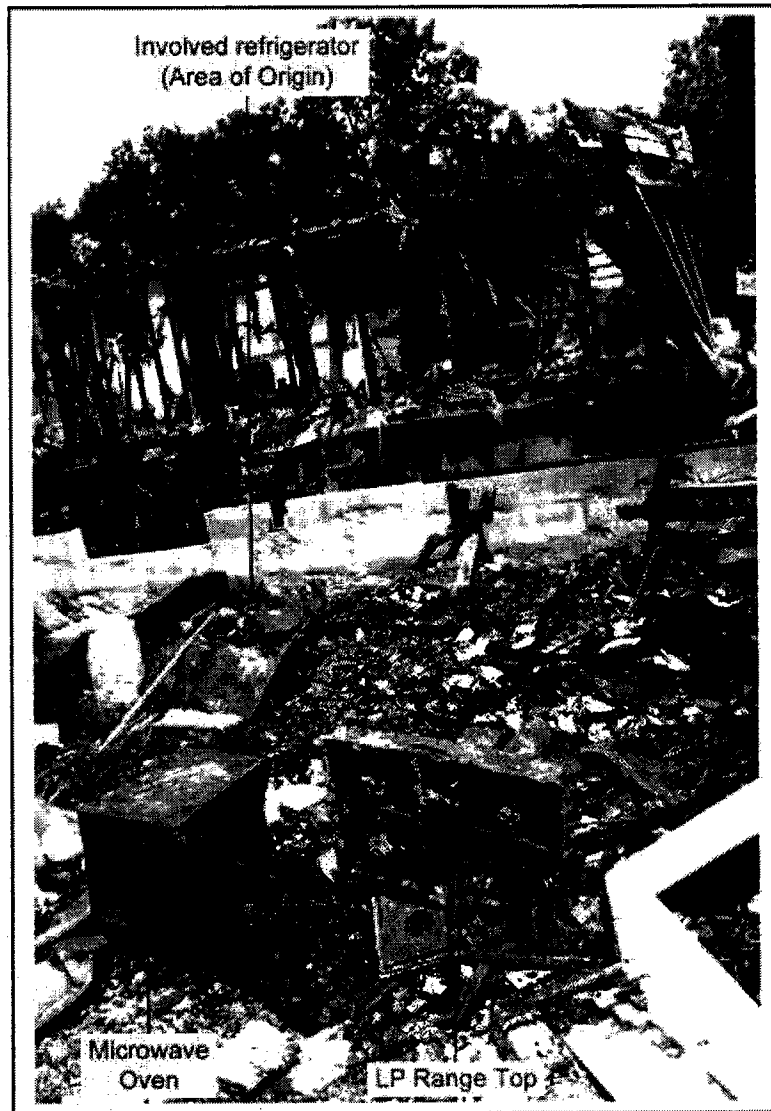
013

View of the
microwave oven &
LP range top near
the involved
refrigerator
